KENYA PLANT HEALTH AND  
INSPECTORATE SERVICE (KEPHIS)  
USABILITY AND ACCESSIBILITY  
AUDIT REPORT FY 2022/23.  
PREPARED BY NCPWD

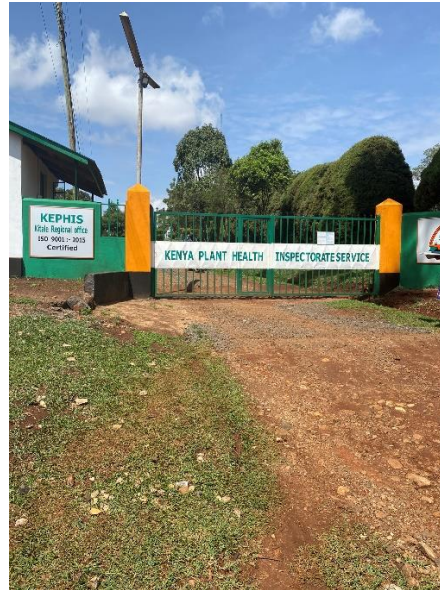
Main Entrance

- The gate is wide enough for vehicles and there is connectivity for pedestrians
- There is connectivity from the main road to the gate area and from gate area to the main entrance
- The floor texture has gravel and soil which hinders access by the PWDs.
- KEPHIS sign and sign for the building are clear and visible.
- The facility does not have tactile walking surface indicators (TWSI) to guide the blind and low vision staff and visitors.

- The path/road leading to the main offices and parking areas should be made accessible by either installing cabro, tarmacked or use other material that is rough and level for ease of access.
- Provide TWSI from drop of point through security gate to main entrance to from the drop of point through the security gate and the main entrance to guide the blind and low vision staff and visitors.

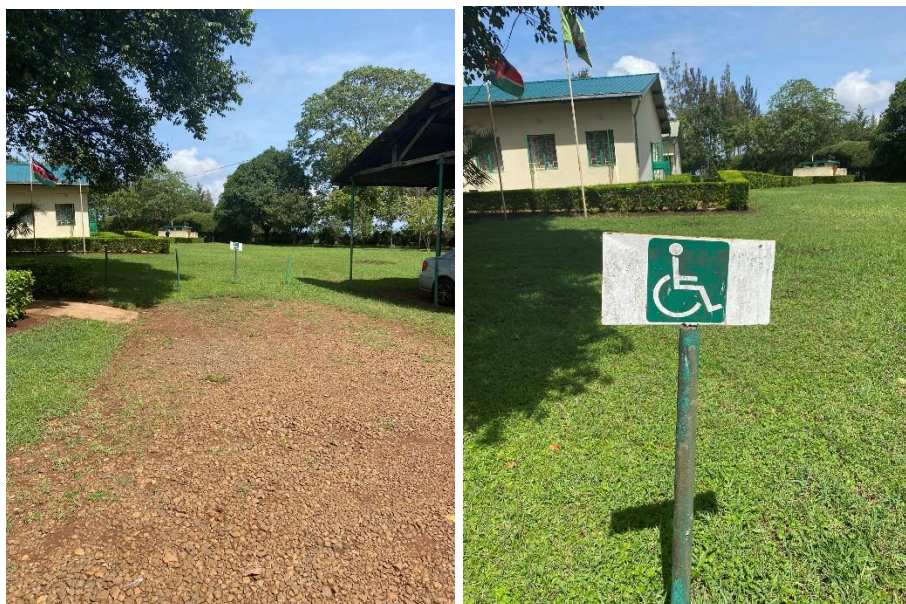
- The facility has reserved one parking space for PWDs.
- The parking space is signed, however, the signs do not meet universal design and accessibility standard for PWDs parking.
- The parking space surface is not level and has gravel rendering the parking space inaccessible to PWDs.

- KEPHIS should reserve one parking space for every 10 parking space for use by persons with disabilities. The parking spaces should be marked and a signage put at the main gate to direct PWDs to their designated parking spaces in line with KS ISO 21542 standards on Built environment by KEBS.
- Designated parking spaces should be located on firm and level ground, as close as is reasonable to the principal accessible entrance to the building with which the parking spaces are associated but no further than 50 m away from the entrance to the building.
- A parking space designated as one for persons with disability shall have a minimum width of 5,400mm and a minimum length of 6,300mm for perpendicular parking and a minimum length of 6.6 m for parallel parking.
- Parking spaces shall have an access aisle at least 1500 mm wide along the entire length of the parking space.

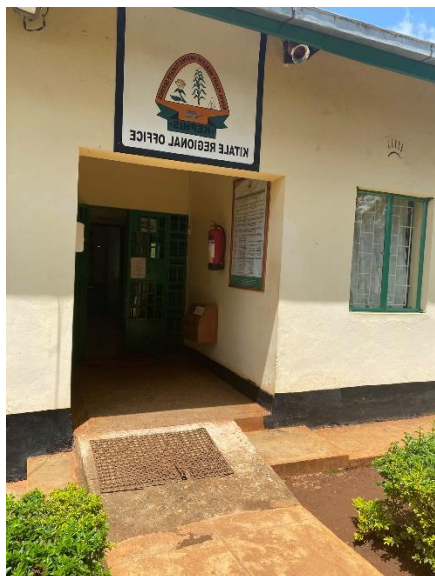
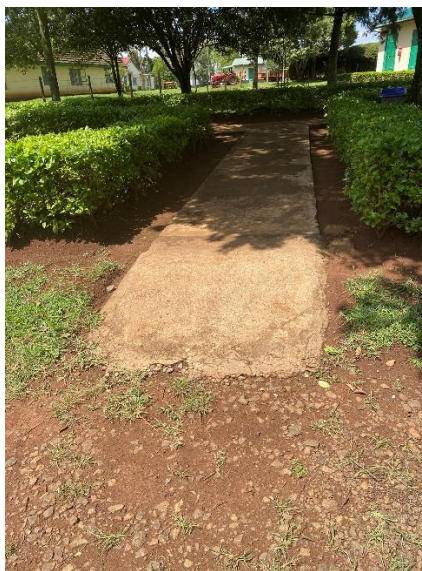
- The ramp leading to the main building and reception area is accessible.
- There is a ramp that does not meet the standard at the entry point from the parking.

*Accessible ramp however, it has no handrails. Inaccessible ramp, it also has no handrails.*

- The accessible ramp has no rails and is next to some stairs which can be hazardous to wheelchair users and other Persons with Disabilities using mobility devices.
- There are no warning and direction tactile walking surface indicators to guide the blind and those with low vision.

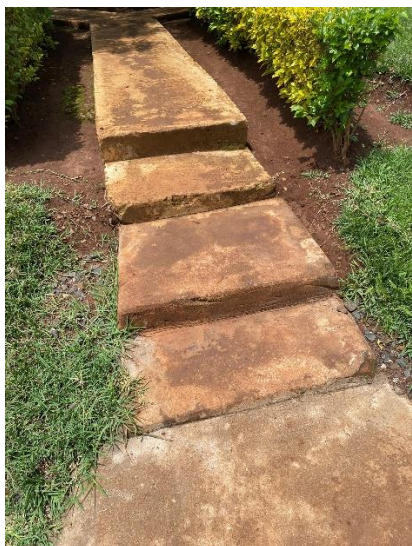
- There are other areas within the premises that have slopes and steps. The slopes do not meet universal design and accessibility standard required for ramps gradient ratio of 1:20

*Inaccessible route*

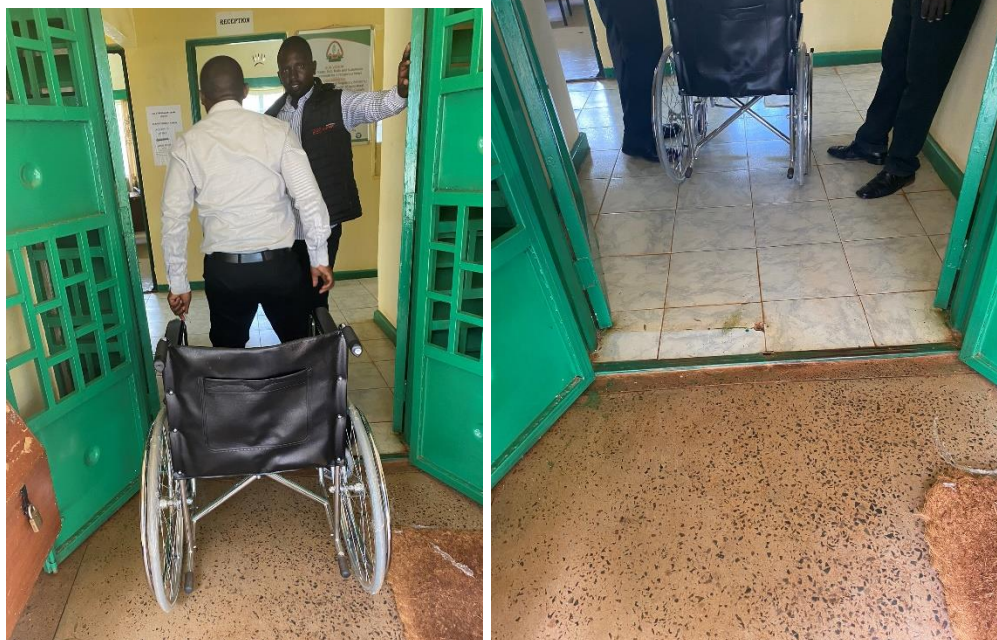
- The main entry is of metal and has a firm grip door handle
- The door is wide enough for a wheelchair user to wheel in and out without difficulties.
- The door has access ramp.

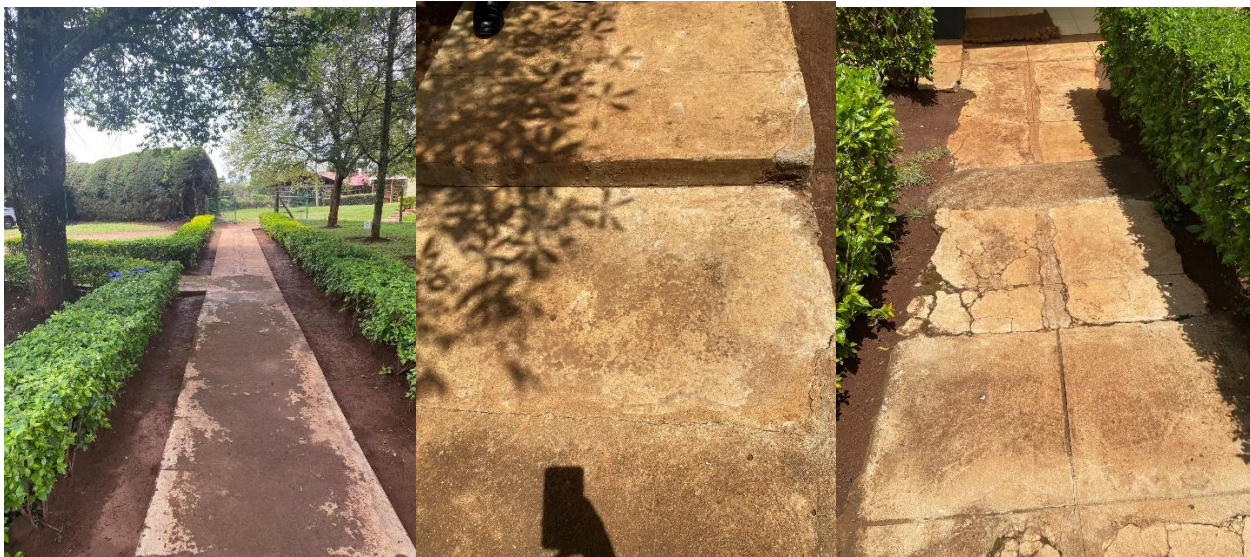
- The pathways do not meet the international standards. They are narrow and have open drainage systems which is hazardous to the pedestrians and those using assistive mobility devices.
- The pathways need repair and some has some steps.

- The pathways need to be renovated according to the ISO standard.
- The drainage should be protected, either by installing a metal cover or installing handrails on along the pathway.

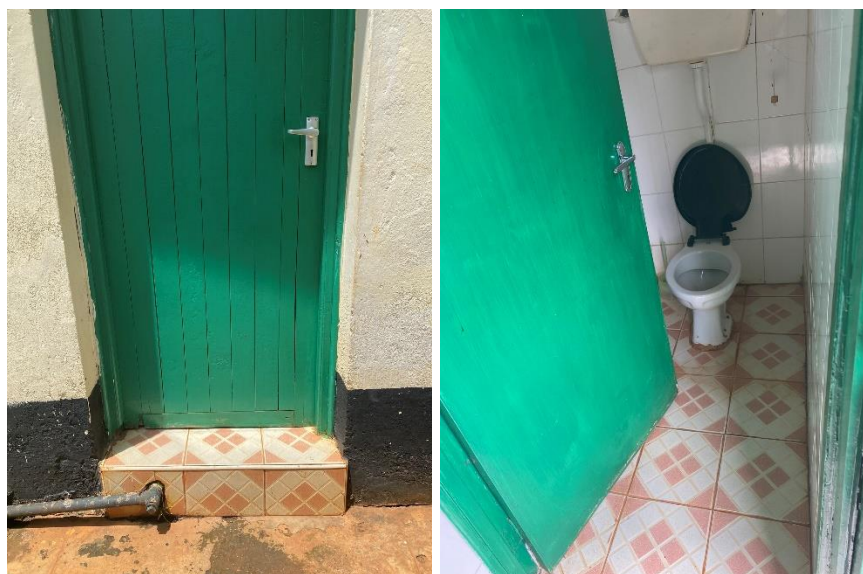
The KEPHIS Kitale washrooms are not accessible to PWDs.

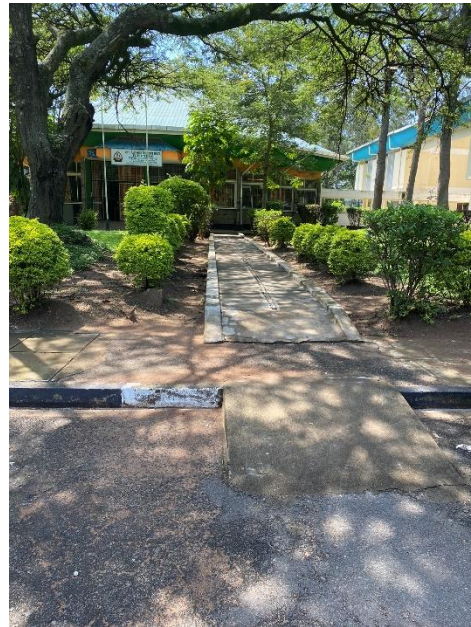
Main Entrance

- The gate is wide enough for vehicles and there is connectivity for pedestrians
- There is connectivity from the main road to the gate area and from gate area to the main entrance
- KEPHIS sign and sign for the building are clear and visible.
- The facility does not have tactile walking surface indicators (TWSI) to guide the blind and low vision staff and visitors.

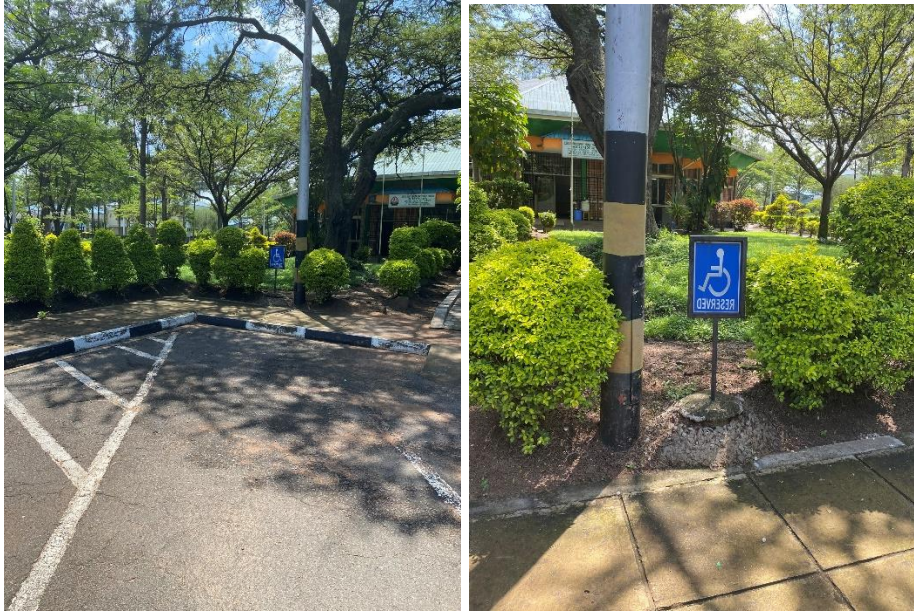
- The parking space have proper signage.
- The parking space surface is level and is therefore accessible to PWDs.

- KEPHIS should reserve one parking space for every 10 parking space for use by persons with disabilities. The parking spaces should be marked and a signage put at the main gate to direct PWDs to their designated parking spaces in line with KS ISO 21542 standards on Built environment by KEBS.

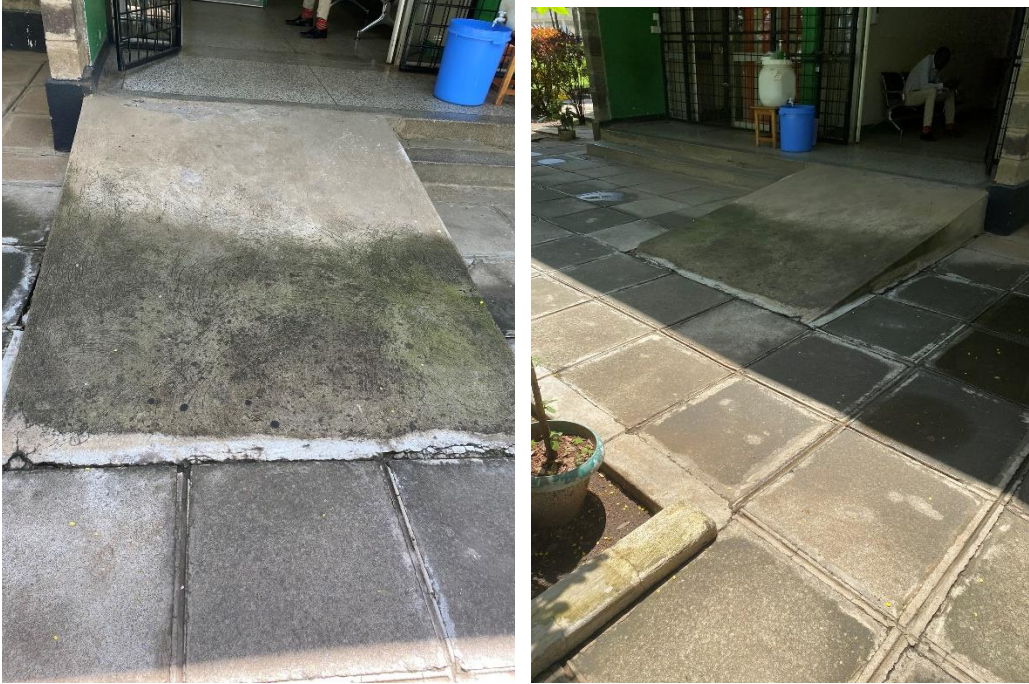
- The ramp leading to the main building and reception area is accessible.
- The ramps are well protected from the drainage system.

*Accessible ramp however, it has no handrails.*

- Install handrails.

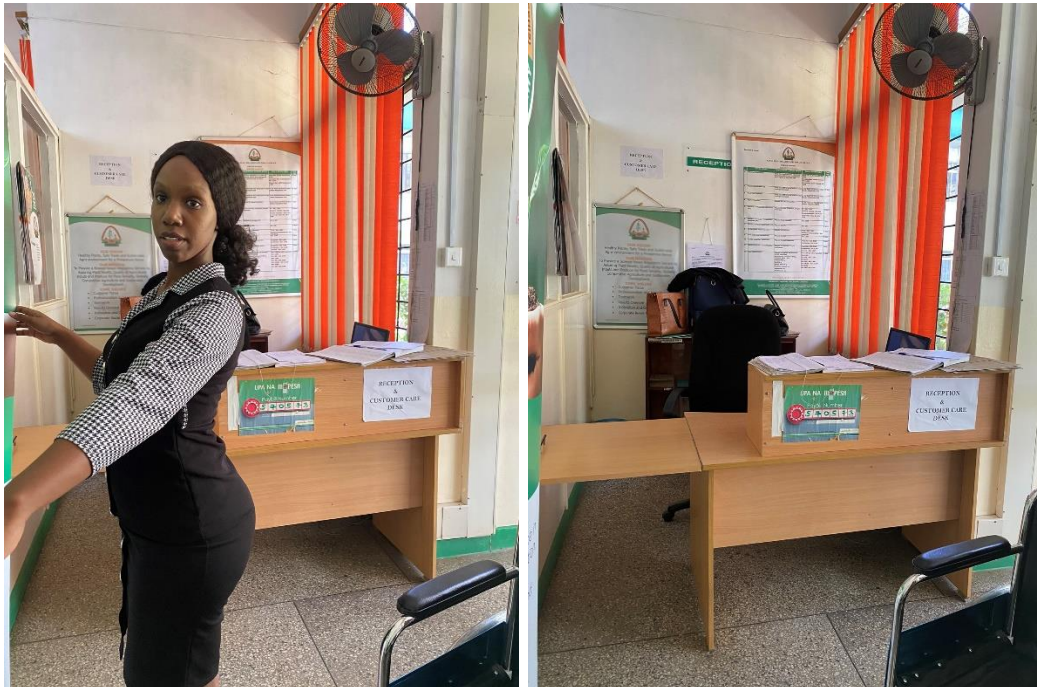
### Main Reception

- The reception personnel is friendly and courteous to visitors.
- Spacious and well accessible to all users.
- Waiting chairs and tables are well spaced, the tables are of good height. The waiting space is accessible.
- The counter/reception is accessible to all including wheelchair users and short stature persons.
- Quiet and peaceful environment.
- Good furniture accessible to persons with disabilities.
- Nice atmosphere / Pleasant ambience / Interior architecture / Clean.
- Natural air-conditioned environment / Pleasant indoor temperature.
- Good spaces for collaboration and maneuver.
- Good lighting and ventilation systems.
- Not overcrowded and supports visual privacy.
- Information is available in Braille format.
- The floor is non slippery.

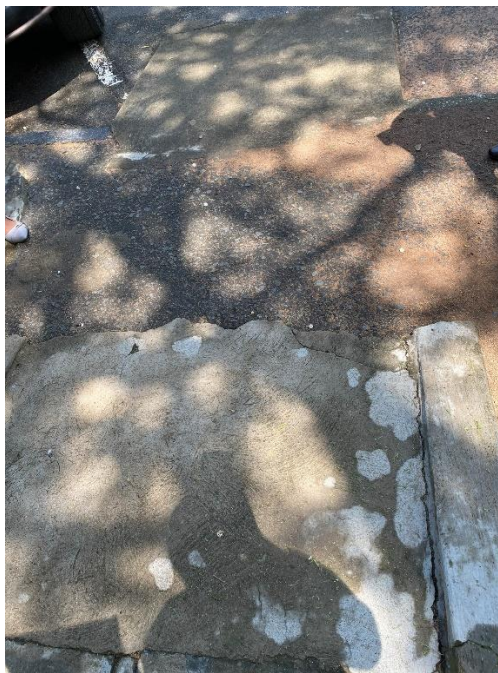
- The pathways meet the international standards.
- The pathways need repair.

- The pathways need to be renovated according to the ISO standard.

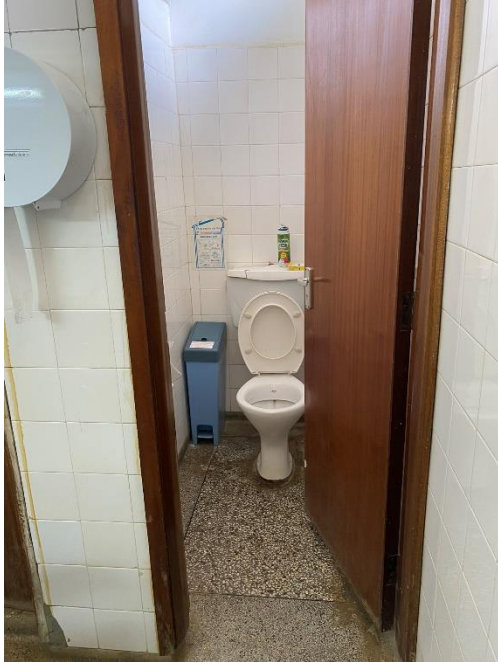
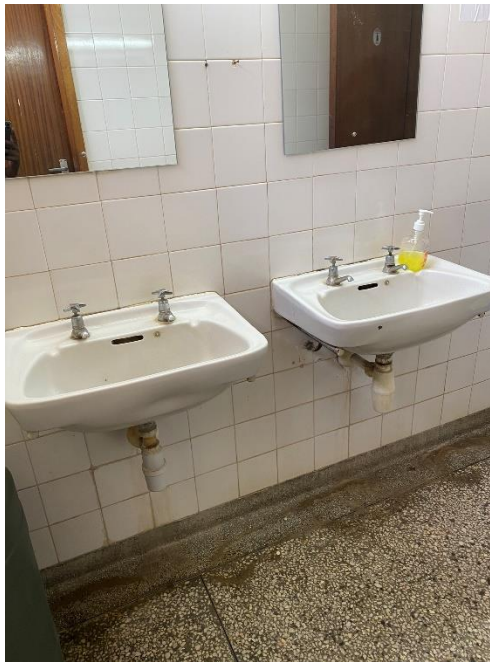
There is no accessible washroom for PWDs.

- KEPHIS should install/construct an accessible washroom for PWDs at the Regional office.

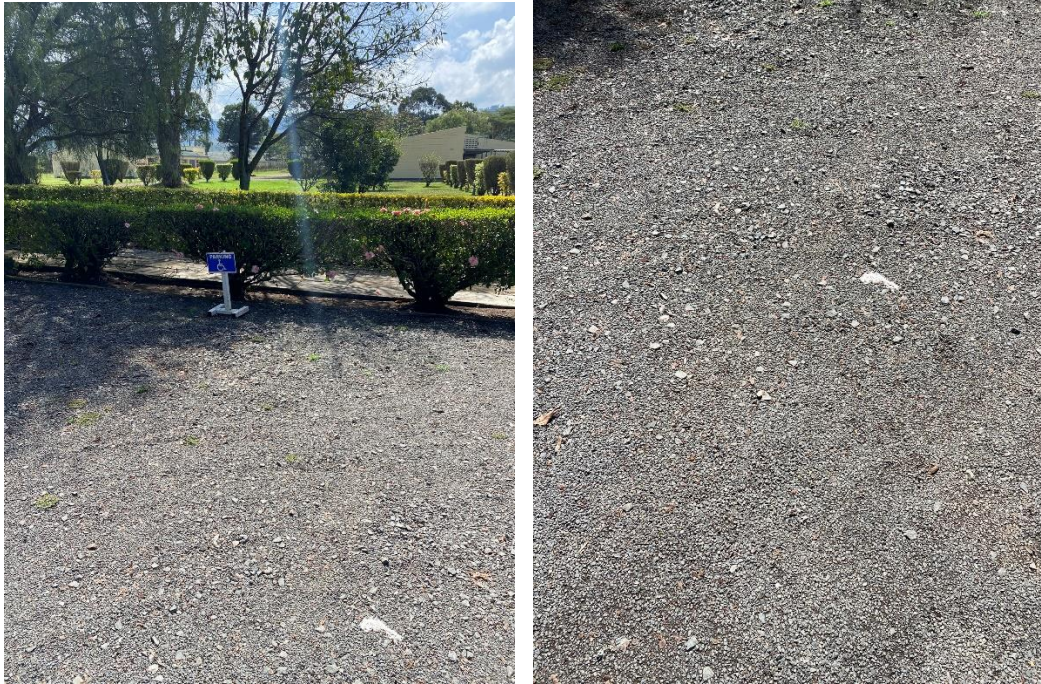
- The facility has reserved one parking space for PWDs.
- The parking space have proper signage.
- The parking space surface is has gravel and therefore not accessible to PWDs.

- KEPHIS should reserve one parking space for every 10 parking space for use by persons with disabilities. The parking spaces should be marked and a signage put at the main gate to direct PWDs to their designated parking spaces in line with KS ISO 21542 standards on Built environment by KEBS.
- The surface needs to be leveled and reconstructed using firm material like tarmac or cabro paving.

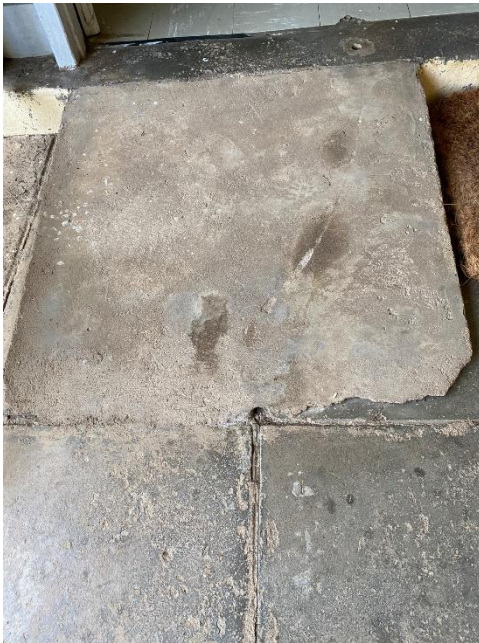
*Accessible ramp however,  
it has no handrails.*

- Install standard ramp at the main entrance.
- Install handrails.
- Install a ramp at the auxiliary door leading to the canteen.

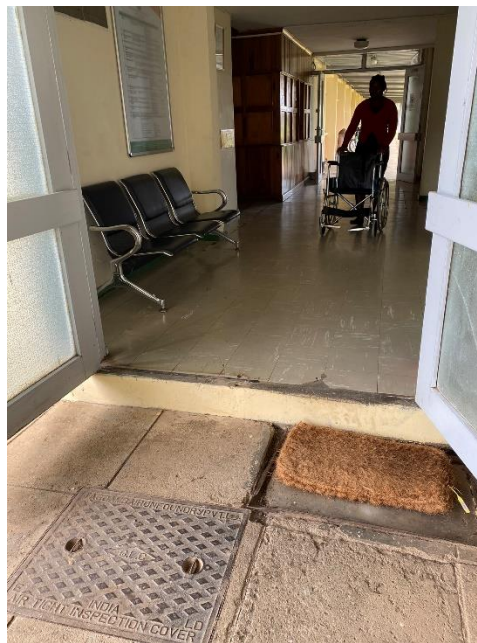
- The ramp leading to the main building and reception area is fairly accessible.
- The ramps do not have handrails.
- Some of the ramps in the facility are not accessible.
- The auxiliary door leading to the canteen has no ramp installed.

*Proper ramp needs to be installed at the entrance*

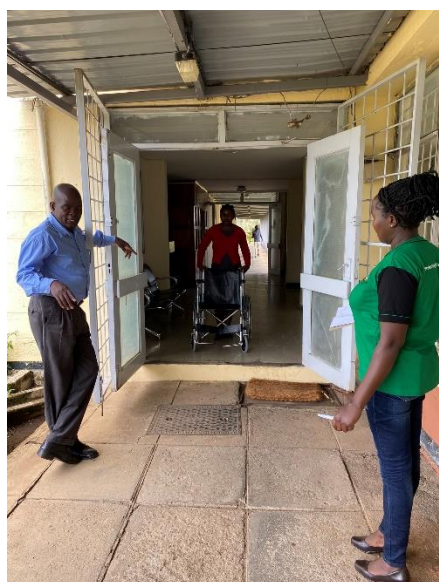
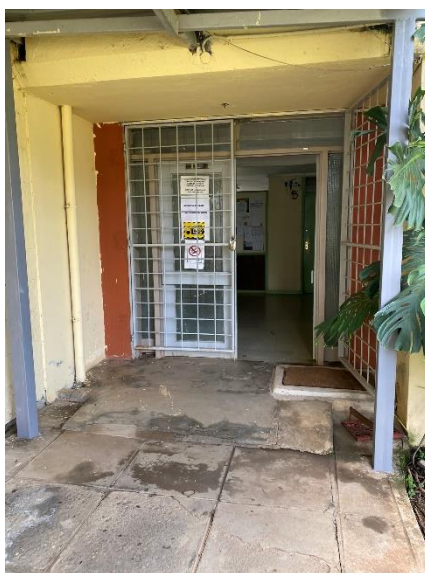
- The main entry is of glass and metal and has a firm grip door handle
- The door is wide enough for a wheelchair user to wheel in and out without difficulties.

- Construct a ramp in line with ISO Standard on built environment at the entrance.

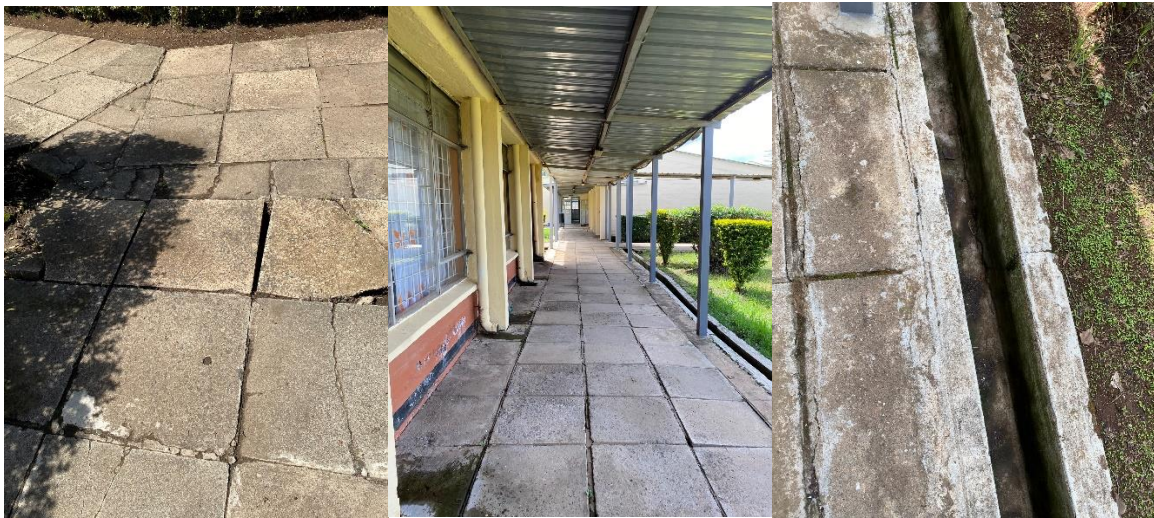
- The pathways meet the international standards.
- The pathways need to be repaired.

- The pathways need to be renovated according to the ISO standard. They pose a hazard.
- The drainage systems need to be protected by using metal covers.

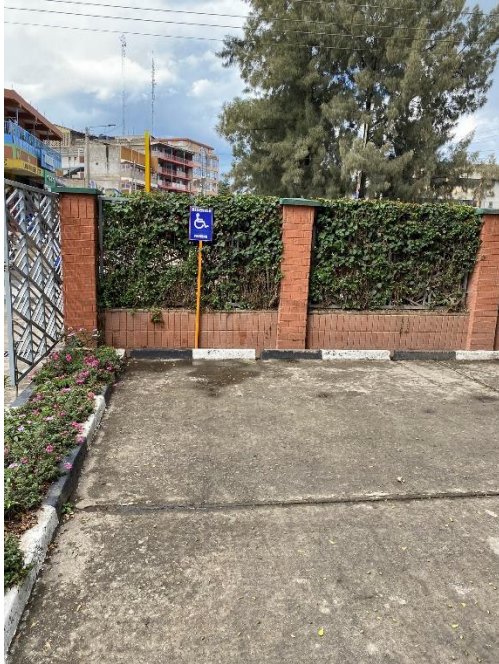
- The parking space have proper signage.
- The parking space surface is level and is therefore accessible to PWDs.

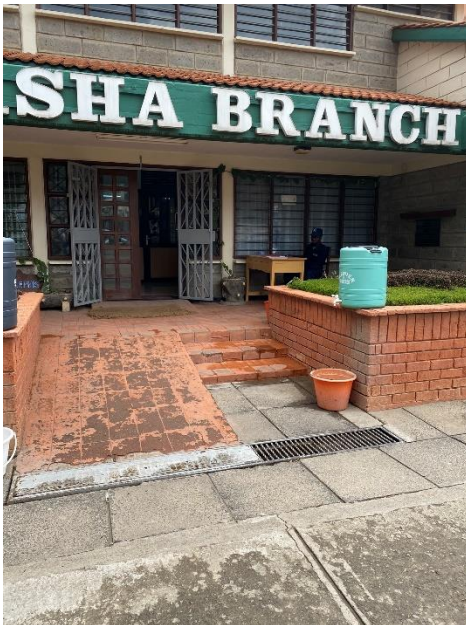
- The ramp leading to the main building and reception area is accessible.
- The ramps are well protected from the drainage system.

*Accessible ramp however, it has no handrails.*

- Install handrails.

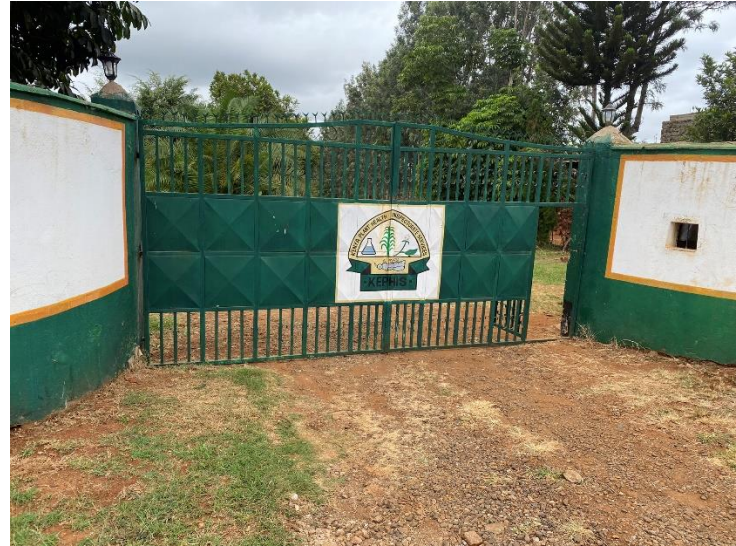
Main Entrance

- The gate is wide enough for vehicles and there is connectivity for pedestrians
- There is connectivity from the main road to the gate area and from gate area to the main entrance
- KEPHIS sign and sign for the building are clear and visible.
- The facility does not have tactile walking surface indicators (TWSI) to guide the blind and low vision staff and visitors.

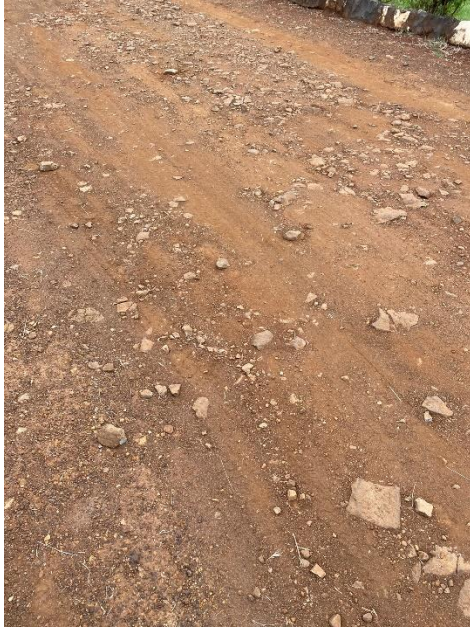
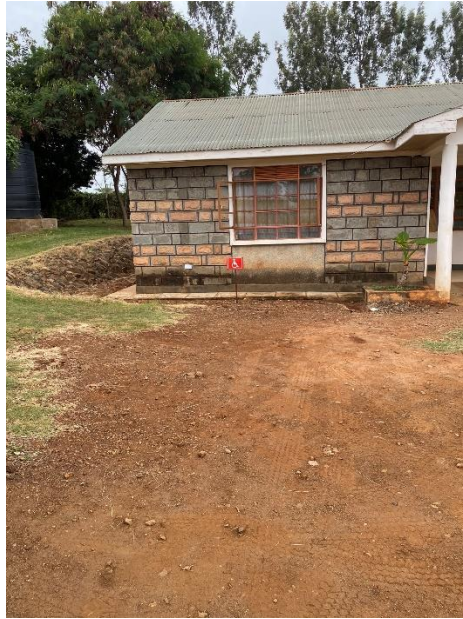
- The security area is open and is accessible to persons with disabilities
- There is a pedestrian entrance at the gate for access to those on foot;
- The surface is not level and firm.

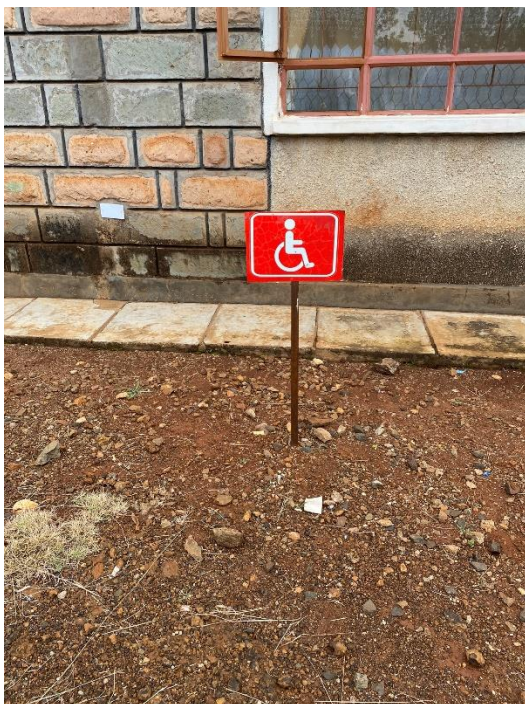
- The facility has reserved a parking space for PWDs.
- The parking space no proper signage.
- The parking space surface is not level and firm, therefore its inaccessible to PWDs.

- KEPHIS should reserve one parking space for every 10 parking space for use by persons with disabilities. The parking spaces should be marked and a signage put at the main gate to direct PWDs to their designated parking spaces in line with KS ISO 21542 standards on Built environment by KEBS.
- The parking surface should be made firm and level.
- The parking sign to be installed and should meet the international accessibility symbol of access standards.

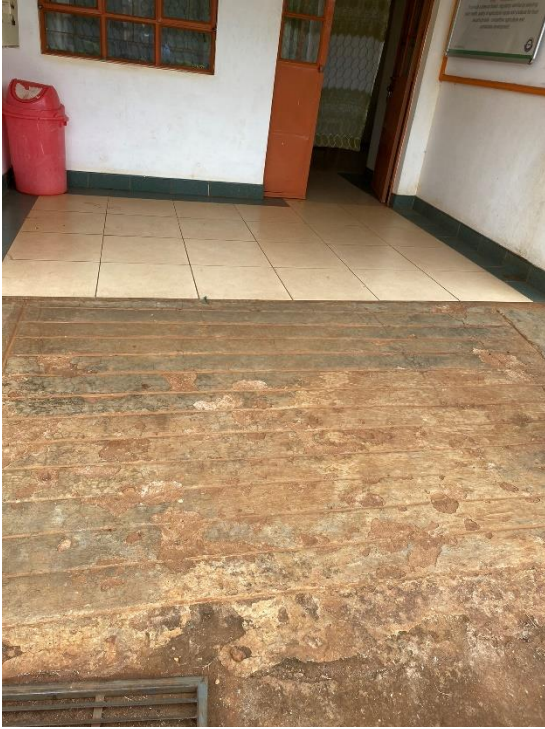
- The ramp leading to the main building and reception area is accessible.
- The ramps are well protected from the drainage system.

*Accessible ramp.*

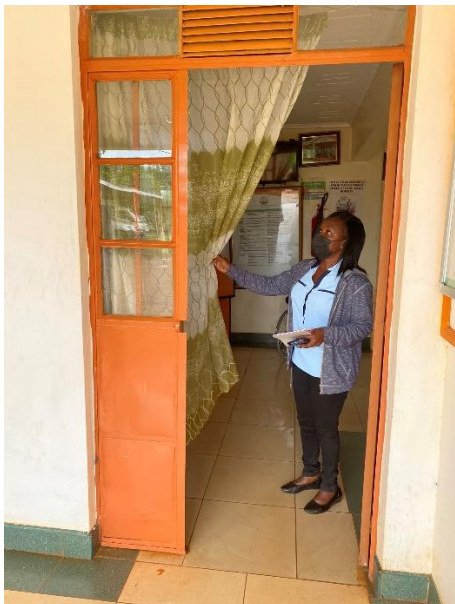
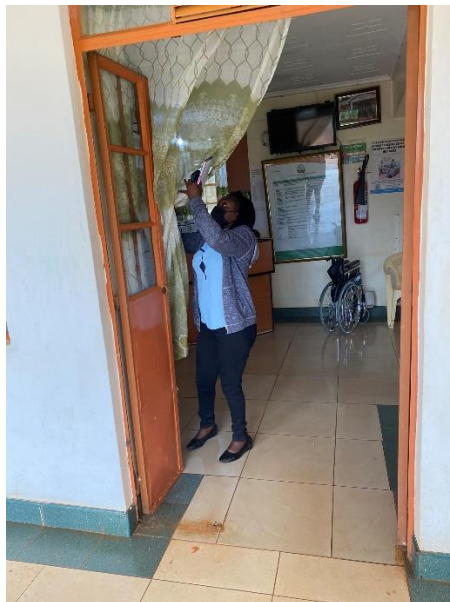
- The main entry is of glass and metal and has a firm grip door handle
- The door is wide enough for a wheelchair user to wheel in and out without difficulties.
- The door has access ramp.

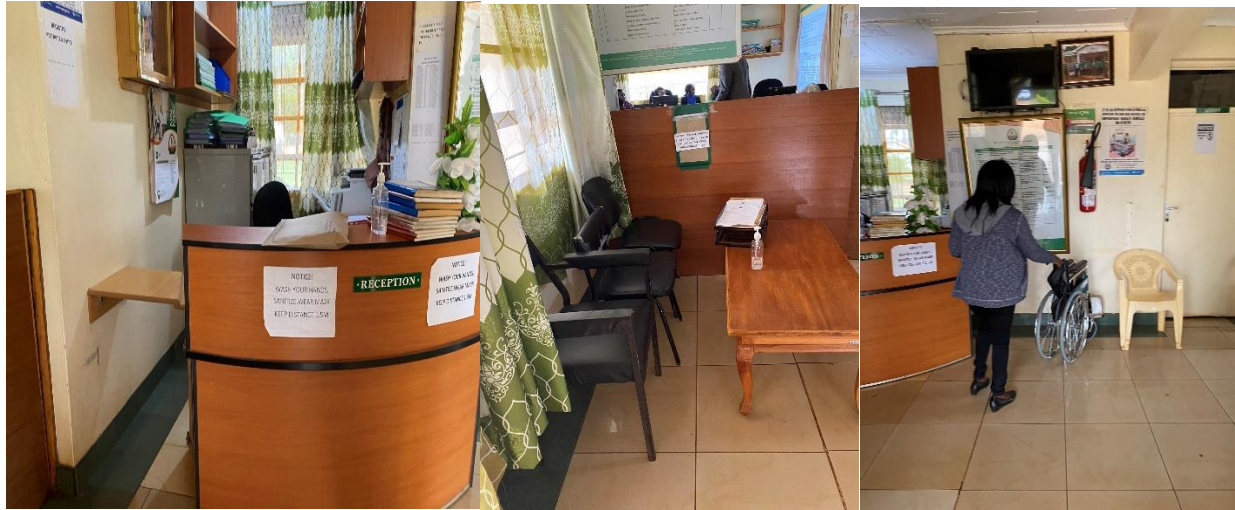
- The receptionist has acquired basic Kenyan Sign Language Skills.
- The reception personnel is friendly and courteous to visitors.
- Waiting chairs and tables are well spaced, the tables are of good height. The waiting space is accessible.
- The counter/reception is accessible to all including wheelchair users and short stature persons.
- Good furniture accessible to persons with disabilities.
- Good spaces for collaboration and maneuver.
- Good lighting and ventilation systems.
- Not overcrowded and supports visual privacy.
- Information is available in Braille format.
- The floor is slippery.

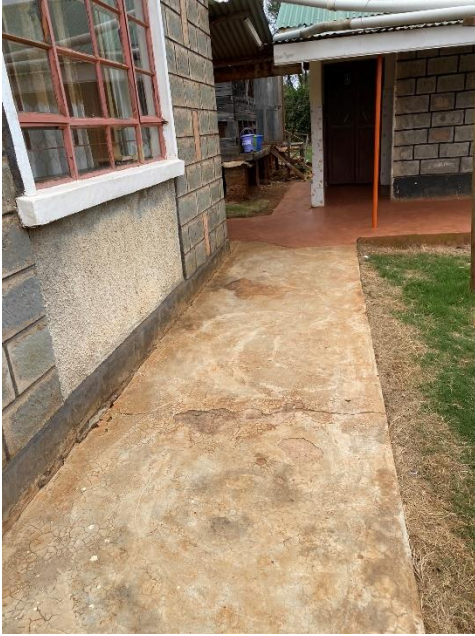
- The pathways are firm and level.

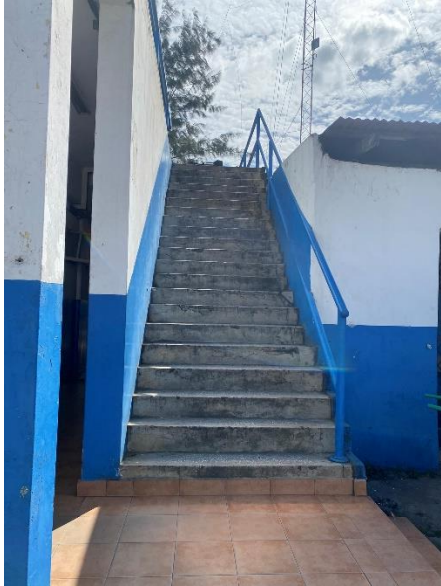
The office in Mombasa is situated at Kenya Ports Authority premises. The office is accessible via a manned gate by Kenya Ports Authority security personell. The office is totally inaccessible to PWDs, however, the Inspectorate has transferred its services to the public to Huduma Center at Posta Mombasa.

*Main Entrance to the Mombasa Office*

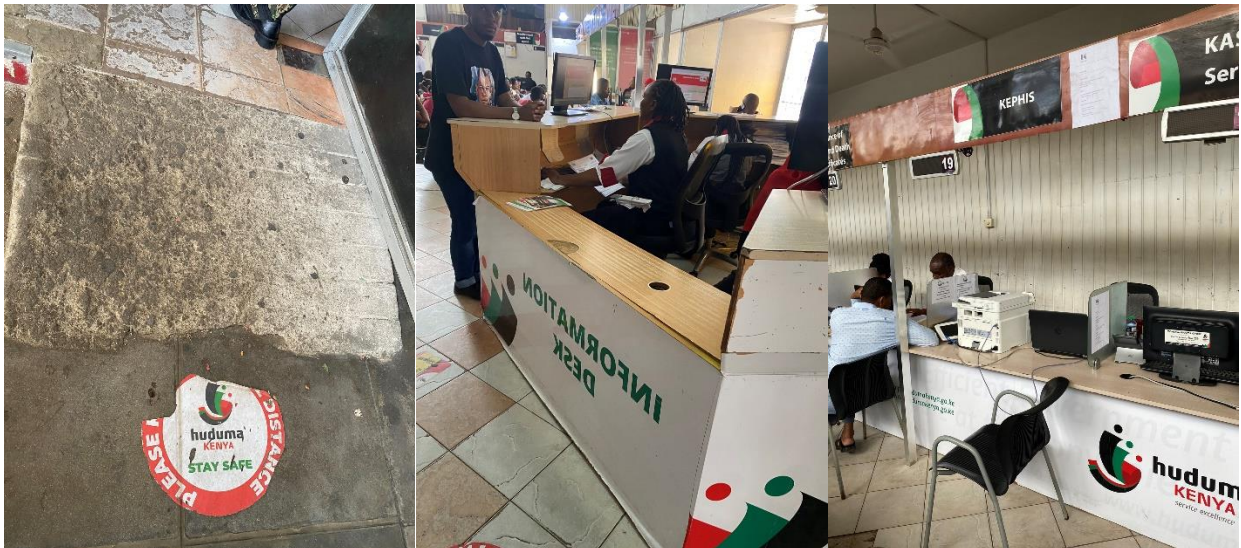
- The office at Huduma center is accessible to persons with disabilities. The ramps have been installed and its near to the drop off point.

*KEPHIS desk at Huduma Center can be accessed by PWDs*

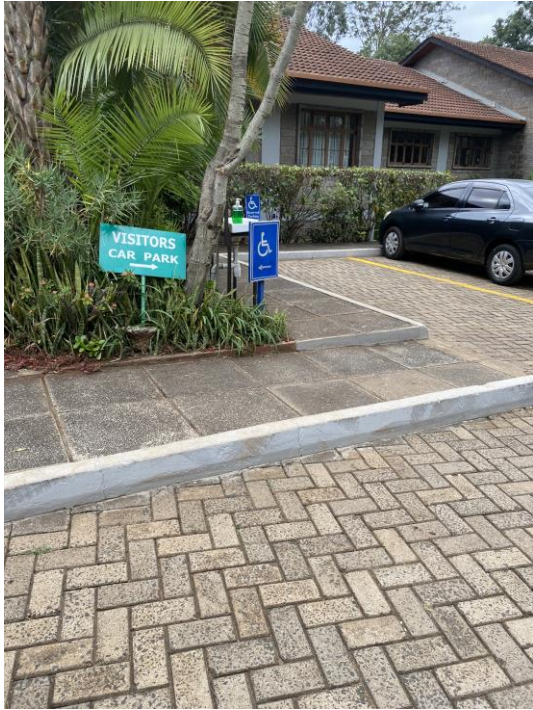
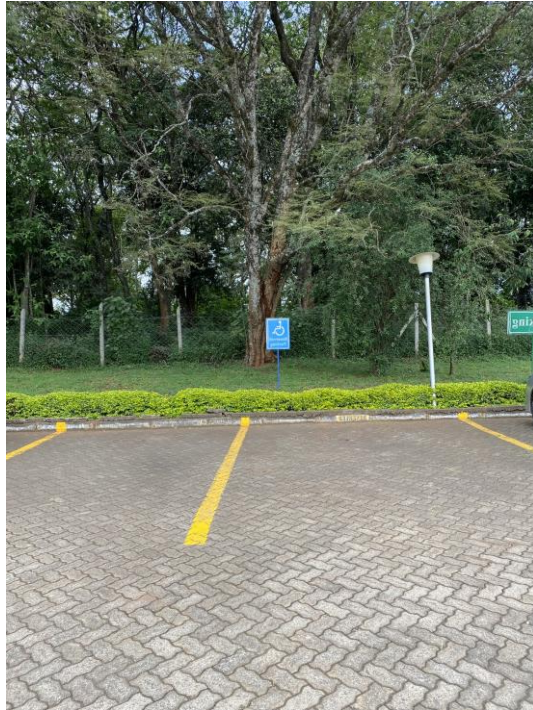
- The facility has reserved parking spaces for PWDs.
- The parking space has proper signage.
- The parking space surface is level and firm.

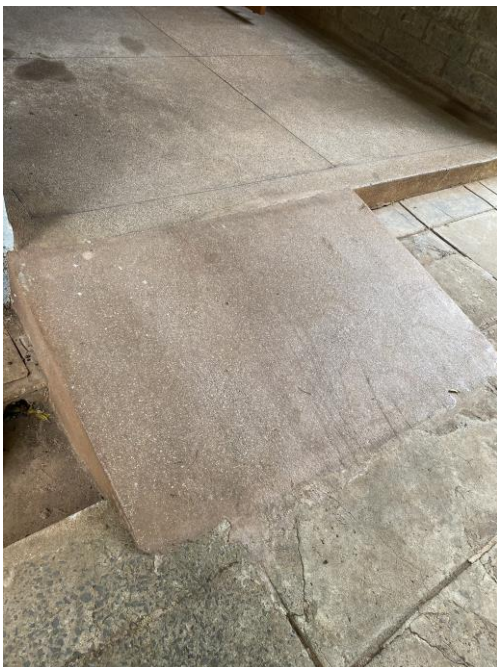
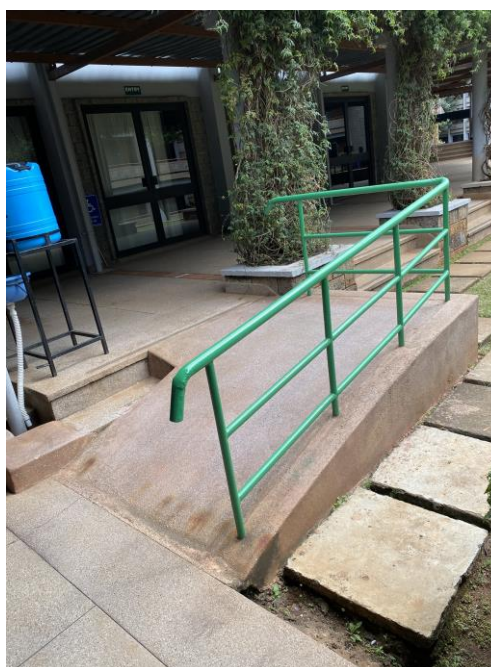
- The ramp leading to the main building and reception area is accessible.
- The ramps in other parts of the premise are also accessible.

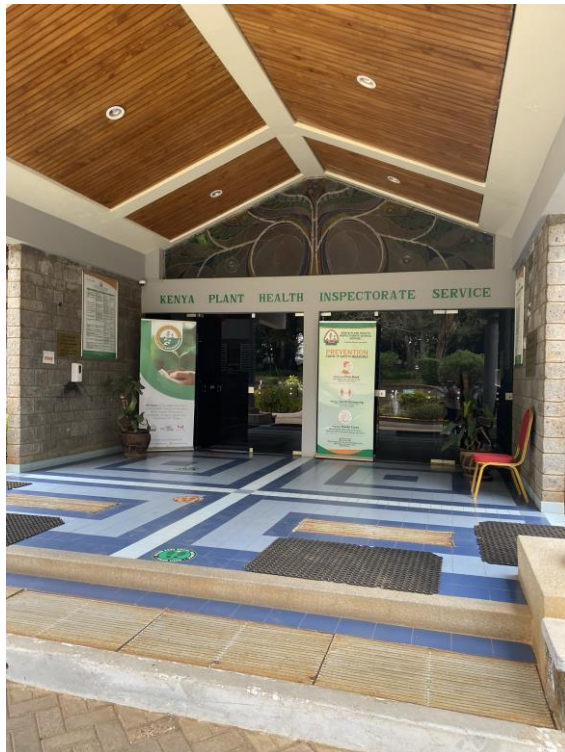
- The main entry is of metal and glass and has a firm grip door handle
- The door is wide enough for a wheelchair user to wheel in and out without difficulties.
- The door has access ramp.

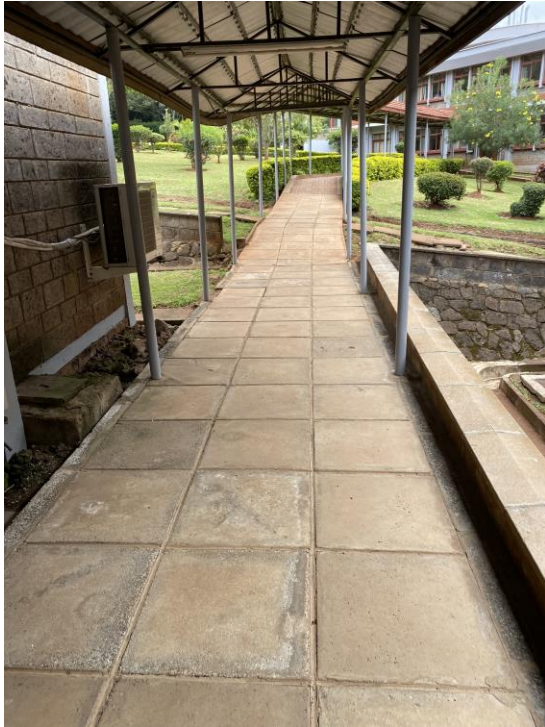
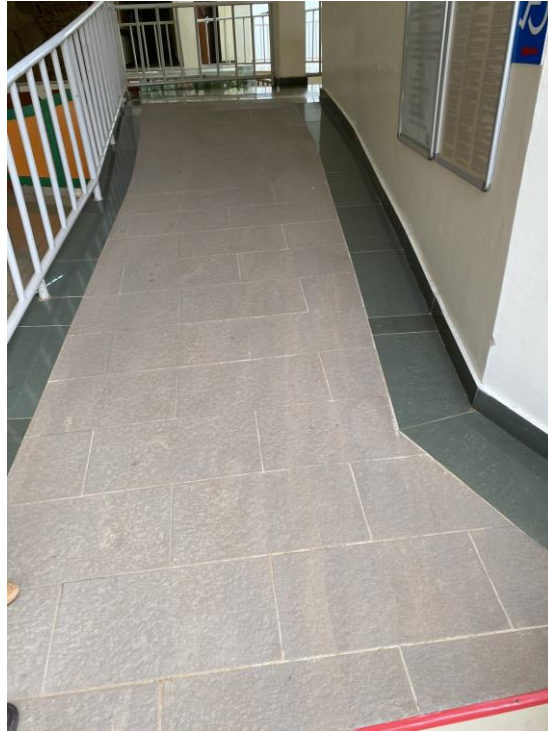
- The pathways meet the international standards

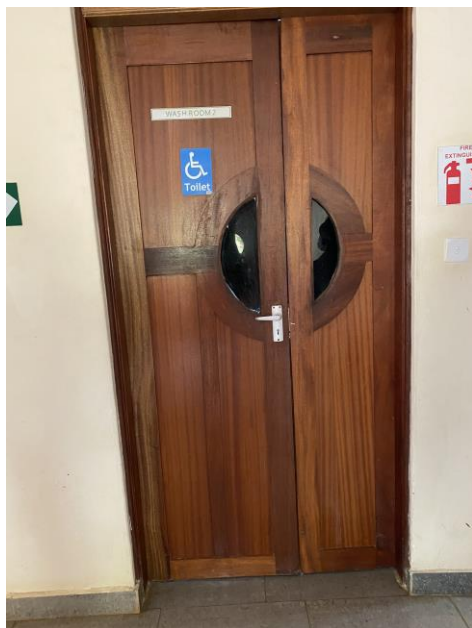
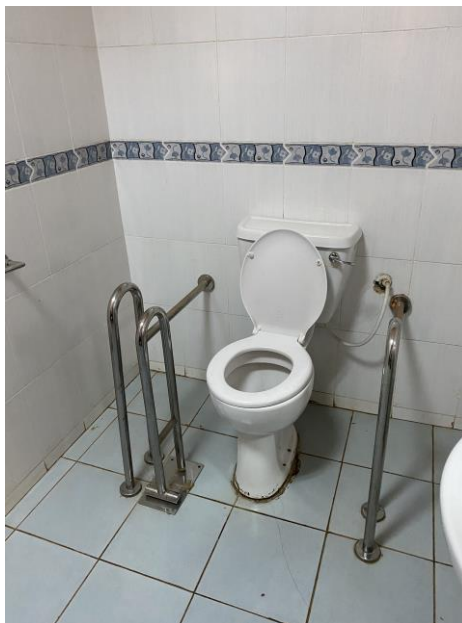
Although KEPHIS have installed washrooms for Persons with Disabilities, the installations of the washrooms do not meet universal design and accessibility to persons with Disabilities. In order to have washrooms that are accessible to all without any form of discrimination, KEPHIS should consult and extensively KEBS ISO 21542 Standards for Building and Construction – Accessibility and Usability of the Built Environment in future modification, office renovation, furniture arrangement and fixture installation to ensure that the improvements meets accessibility needs of persons with Disabilities.

- KEPHIS should modify/install/construct an accessible washroom for PWDs at the Head office.
- The dimension for wheelchair use accessible toilet rooms depends on the function that must be met. The international standard gives the characteristics and requirements for three types (A, B, C) of the toilets most commonly used in the world. National regulations shall decide on the priority of the functions to be met and recommend which type of toilet room is to apply for depending on space available to decide of washroom to install to meet accessibility needs for all.
